## SafeBuy's Pre-Purchase Comprehensive Vehicle Inspection Report

10 Nov 2025 / Inspector 3 / SBCDKD472 / Comprehensive Inspection

| Vehicle Details | |
|---|---|
| Car model and Badge | I40M50 |
| Registration no. | DKD472 |

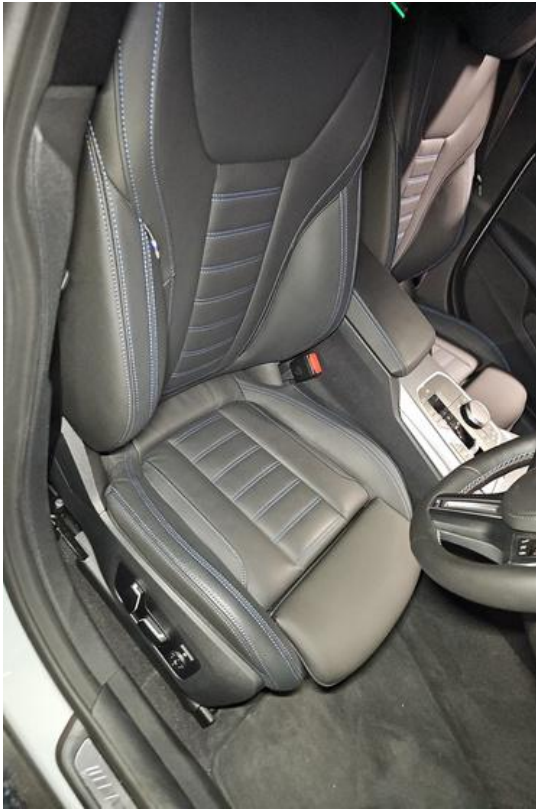
Photo 120

Front and rear seats heater & operation / seats condition

Need Attention

Cup holder lid stuck  
Scratch on passenger seat

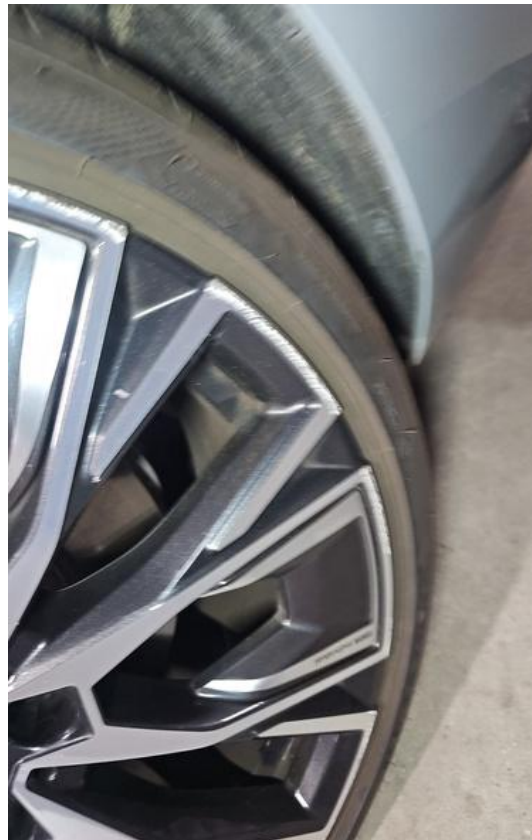
Photo 143

Lhr wheel edges scraped.  
Stope chip on bumper  
Stone chip on rhr wheel arch  
Minor scratch on rh side skirt.
