## SafeBuy's Pre-Purchase Comprehensive Vehicle Inspection Report

10 Nov 2025 / Inspector 3 / SBCDKD472 / Comprehensive Inspection

| Vehicle Details | |
|---|---|
| Car model and Badge | I40M50 |
| Registration no. | DKD472 |

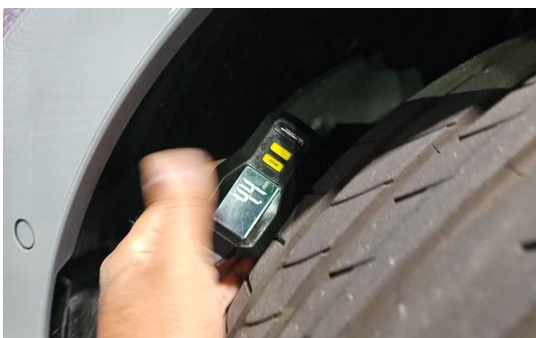
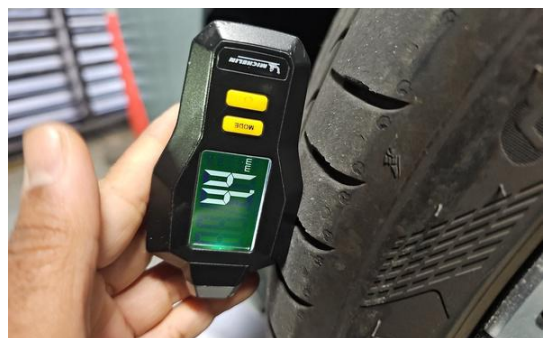
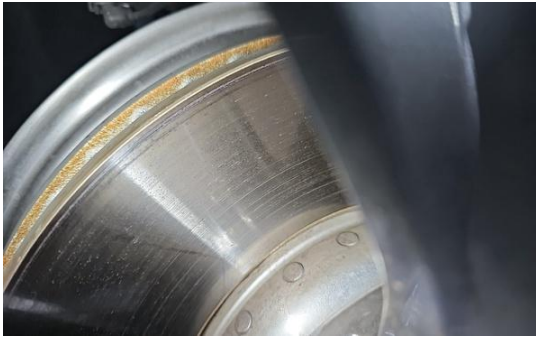
LHF tyre

Need Attention

Air pressure low

| <b>Air pressure low</b><br> <p>Photo 52      Photo 53      Photo 54</p> | | |

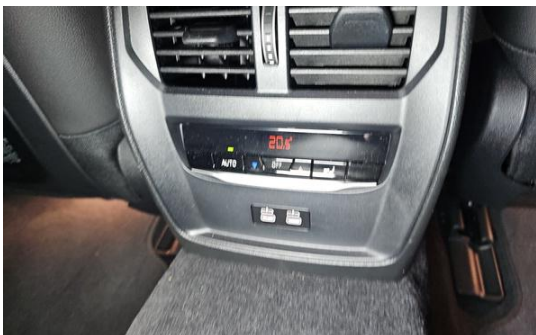
Photo 122

Front and rear seats heater & operation / seats condition

Need Attention
